VEX Technical Information

ASSEMBLY / DISMANTLING

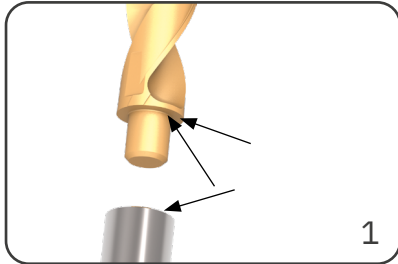
Clean the surfaces between the VEX drill bit and the tool body.

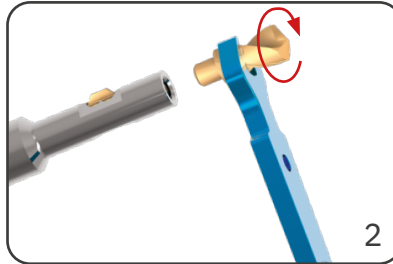
Screw tightly the drill bit with a flat wrench to the tool body.

For torque / torque spanner see page 207.

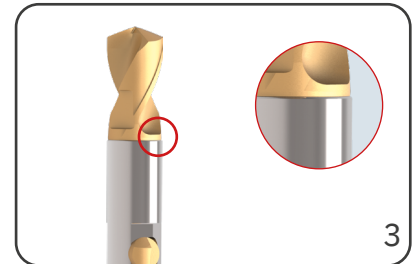
There should be a seamless transition between drill bit and tool body after the tightening of the drill bit (no light gap between tool body and drill bit).

Reasons for a Light Gap and How to Correct

Reason	Solution
Dirt between drill bit and tool body.	Dismantle and clean.
Drill bit is not tightened enough.	Tighten drill bit once more.
Adaption areas are damaged.	Exchange drill bit and/or tool body.

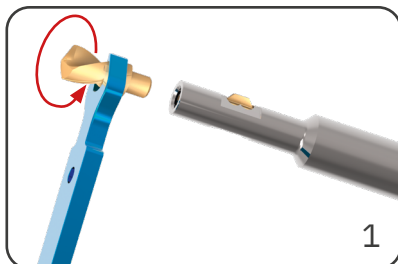
Unfasten the drill bit with a flat wrench in counter-clockwise direction from the tool body.
